## 6144 FEDERAL BLVD., SAN DIEGO — PUBLIC RECORDS FILE

Section 11.70 · United Rentals (North America), Inc. dba Reliable Onsite Services — Sewage Disposal Records

# Photograph Analysis: B.0-B.10 of the South Chollas Creek Channel

## South Chollas Creek Channel outfall and possible discharge pathway, 6144 / 6176 Federal Blvd., San Diego (District 4)

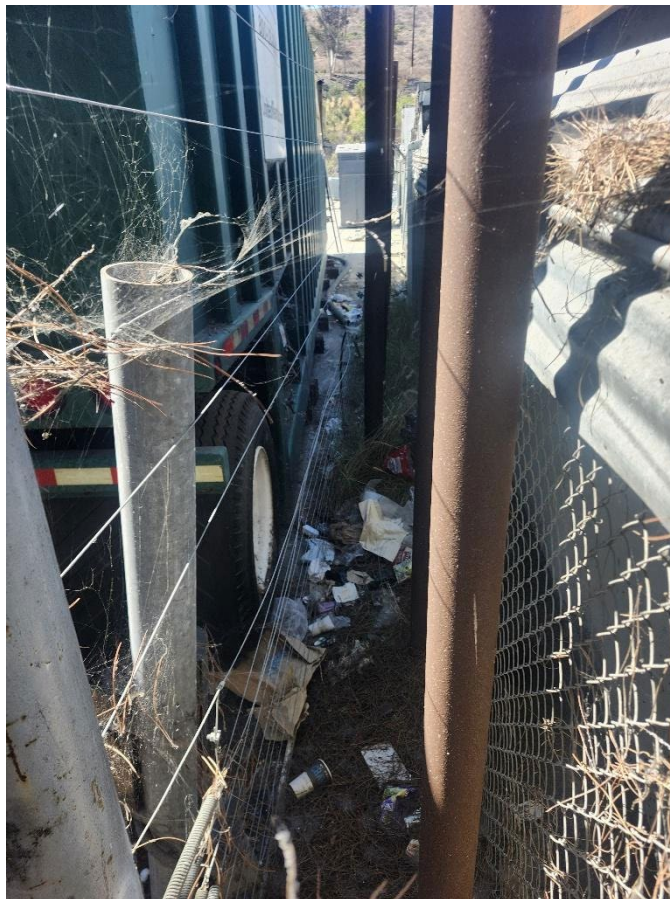
### B.0 — Debris at the yard boundary (June 26, 3:42 pm)

Litter and debris — plastic wrappers, food packaging, a tire, and cardboard — accumulated along the 6144 Federal Blvd. yard's 7,000-volt fence and property boundary line at grade. This is the debris the City storm-water inspector reportedly directed United Rentals to clean up. Establishes housekeeping conditions at the boundary and a route by which loose material can move toward the channel.

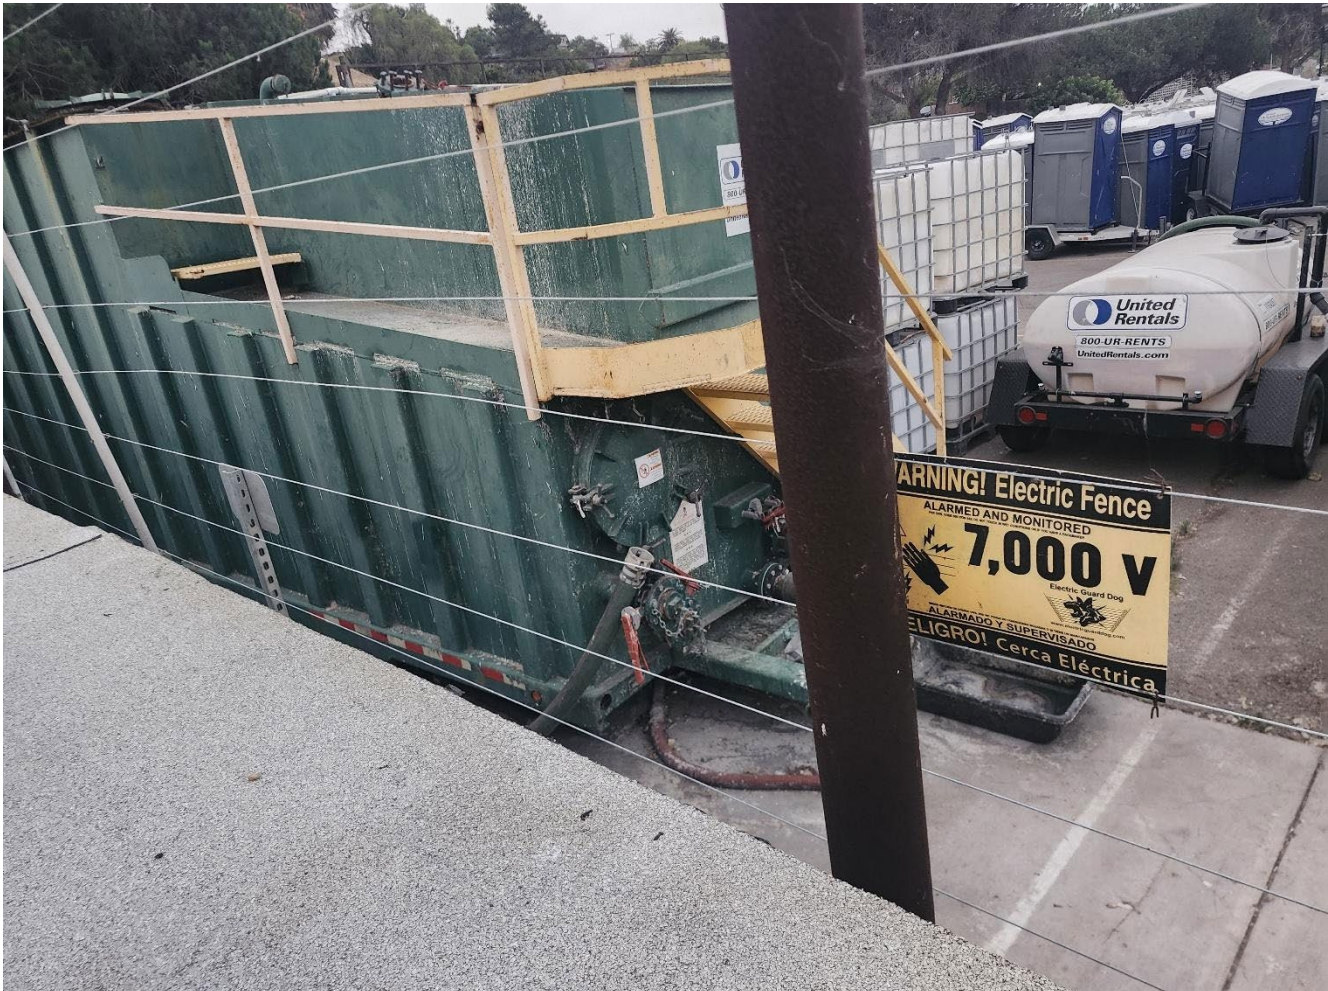
## B.1 — The FRAC tank behind the 7,000-volt electric fence (July 3, 5:38 am)

Close view from the property line: the site's approximately 21,000-gallon FRAC septage holding tank (dark green) sits at the boundary, with valves, fittings, and hoses at its base. A posted sign reads "WARNING! Electric Fence — Alarmed and Monitored — 7,000 V." United Rentals-branded equipment, IBC totes, and rows of portable toilets are staged in the yard. The alarmed, monitored, energized perimeter establishes that the yard is secured and not open to the public, so the conditions shown throughout this exhibit are on controlled ground.

**Compliance note — [San Diego Municipal Code § 142.0390 \(Monitored Perimeter Security Fence Systems\)](#).** In the City of San Diego, an energized "monitored perimeter security fence system" of this type is allowed only in industrial zones that do not allow for residential development (§ 142.0390(c)(1)), and only with a Process One permit, a separate Alarm System Permit, and a signed indemnification agreement with the City. It must be installed 4–8 inches behind a non-electrified perimeter fence at least five feet in height (§ 142.0390(b)(3)), limited to ten feet in height, posted with warning signs at intervals not exceeding 30 feet, and fitted with a Knox device for Police and Fire access. As shown, the energized wire — approximately ten feet high, at the maximum height the code allows (§ 142.0390(b)(4)) — faces the public sidewalk at the property line rather than behind a five-foot non-electrified barrier, so the required setback does not appear to be met, and residentially zoned property lies directly across the street. These raise the question whether an energized security fence is permitted at this location at all — and, if a permit was issued, on what basis.

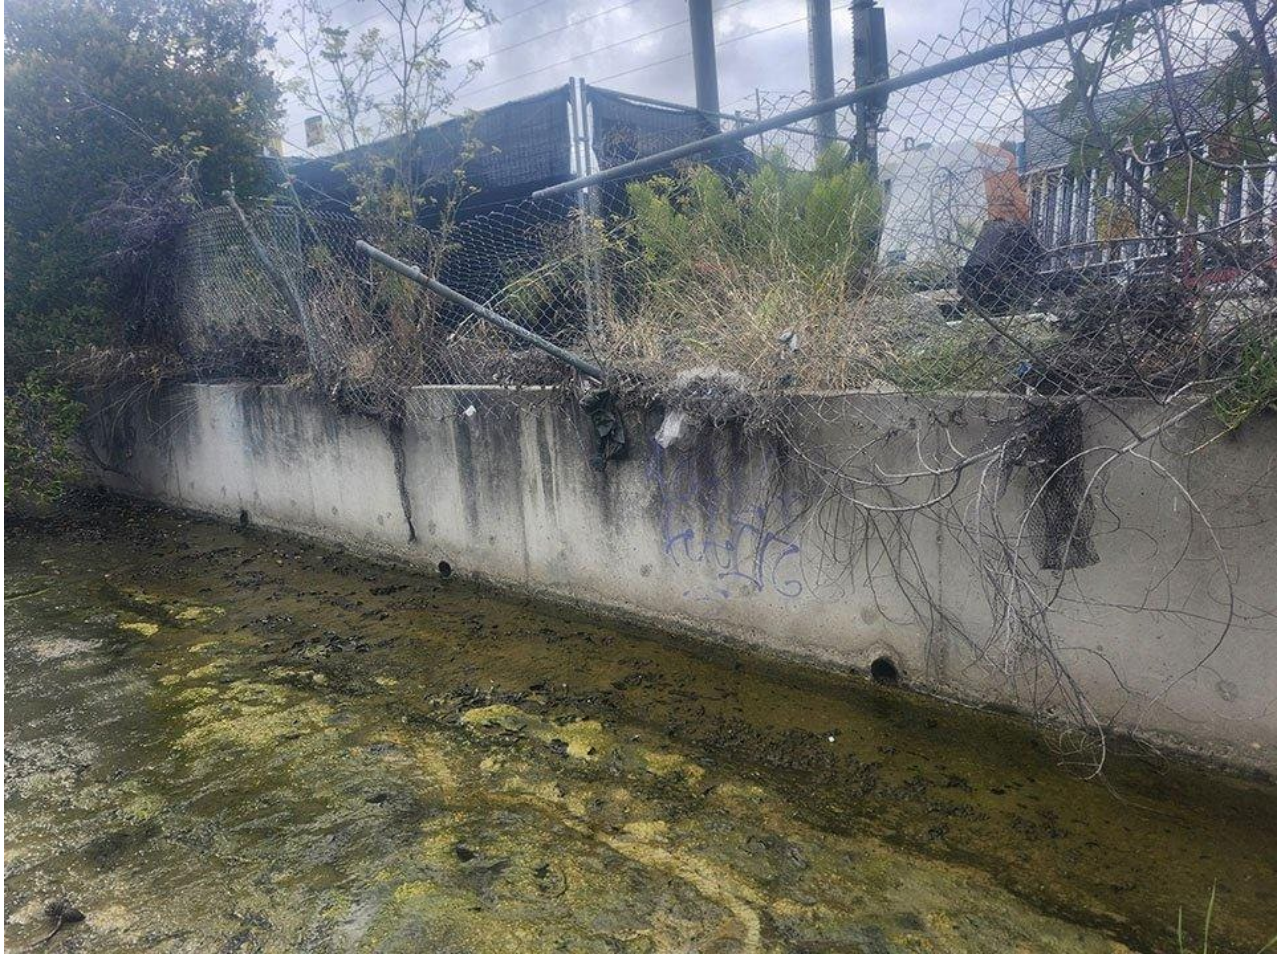
**B.2 — Channel wall below the yard (June 30, 7:11 am)**

The concrete channel wall immediately below the yard, with algae and dark staining in the standing water at the base and small 4" corrugated drainpipe weep-holes in the bottom of the wall. The staining of the concrete wall should be investigated as to cause.

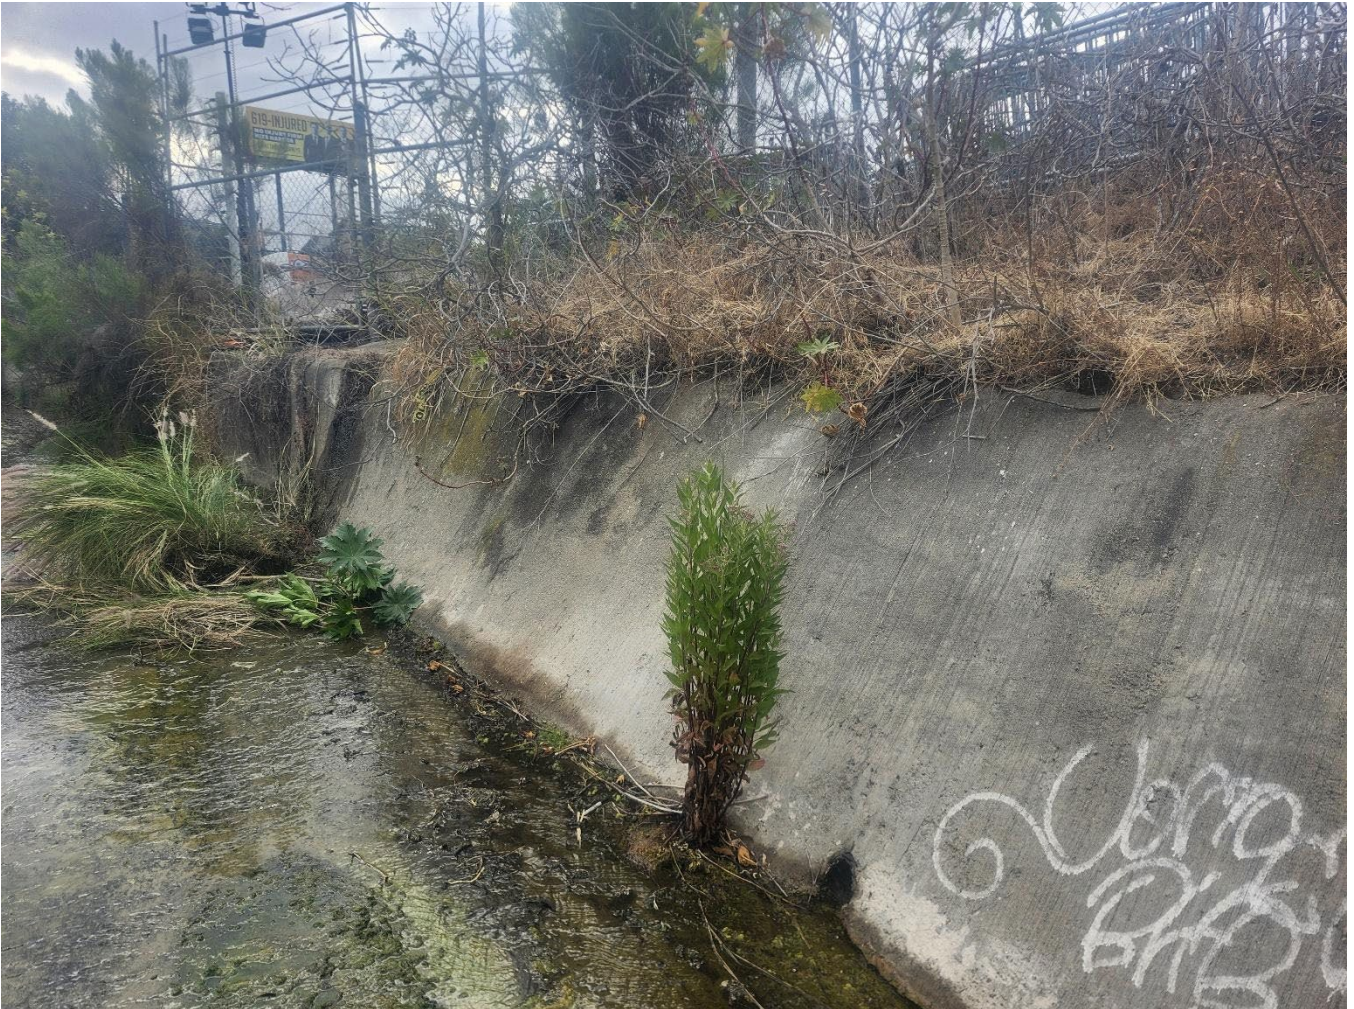
### B.3 — Channel condition and nutrient indicators (June 30, 7:25 am)

The sloped concrete channel with standing water, green algae/duckweed at the invert, and vegetation rooted in the joints — nutrient-enrichment indicators in the channel.

**Water-quality note — elevated fecal-indicator bacteria detected at this section of the channel.** Per the [Chollas Creek Watershed Water Quality Report \(2021–2023\)](#) (San Diego Coastkeeper / Groundwork San Diego—Chollas Creek): at the Federal Boulevard monitoring station — the most upstream site — “in September 2022, all types of bacteria had high levels above water quality standards,” with total-coliform spikes in April 2022, September 2022, and March 2023. The report defines *E. coli* as “a strong indicator of sewage or animal contamination” and enterococcus as indicating “fecal bacteria and the possible presence of disease-causing bacteria, viruses, and protozoa.” Chollas Creek is listed as impaired for pathogens under Clean Water Act § 303(d). These detections are watershed data for this section of the channel; they are not attributed here to any particular source.

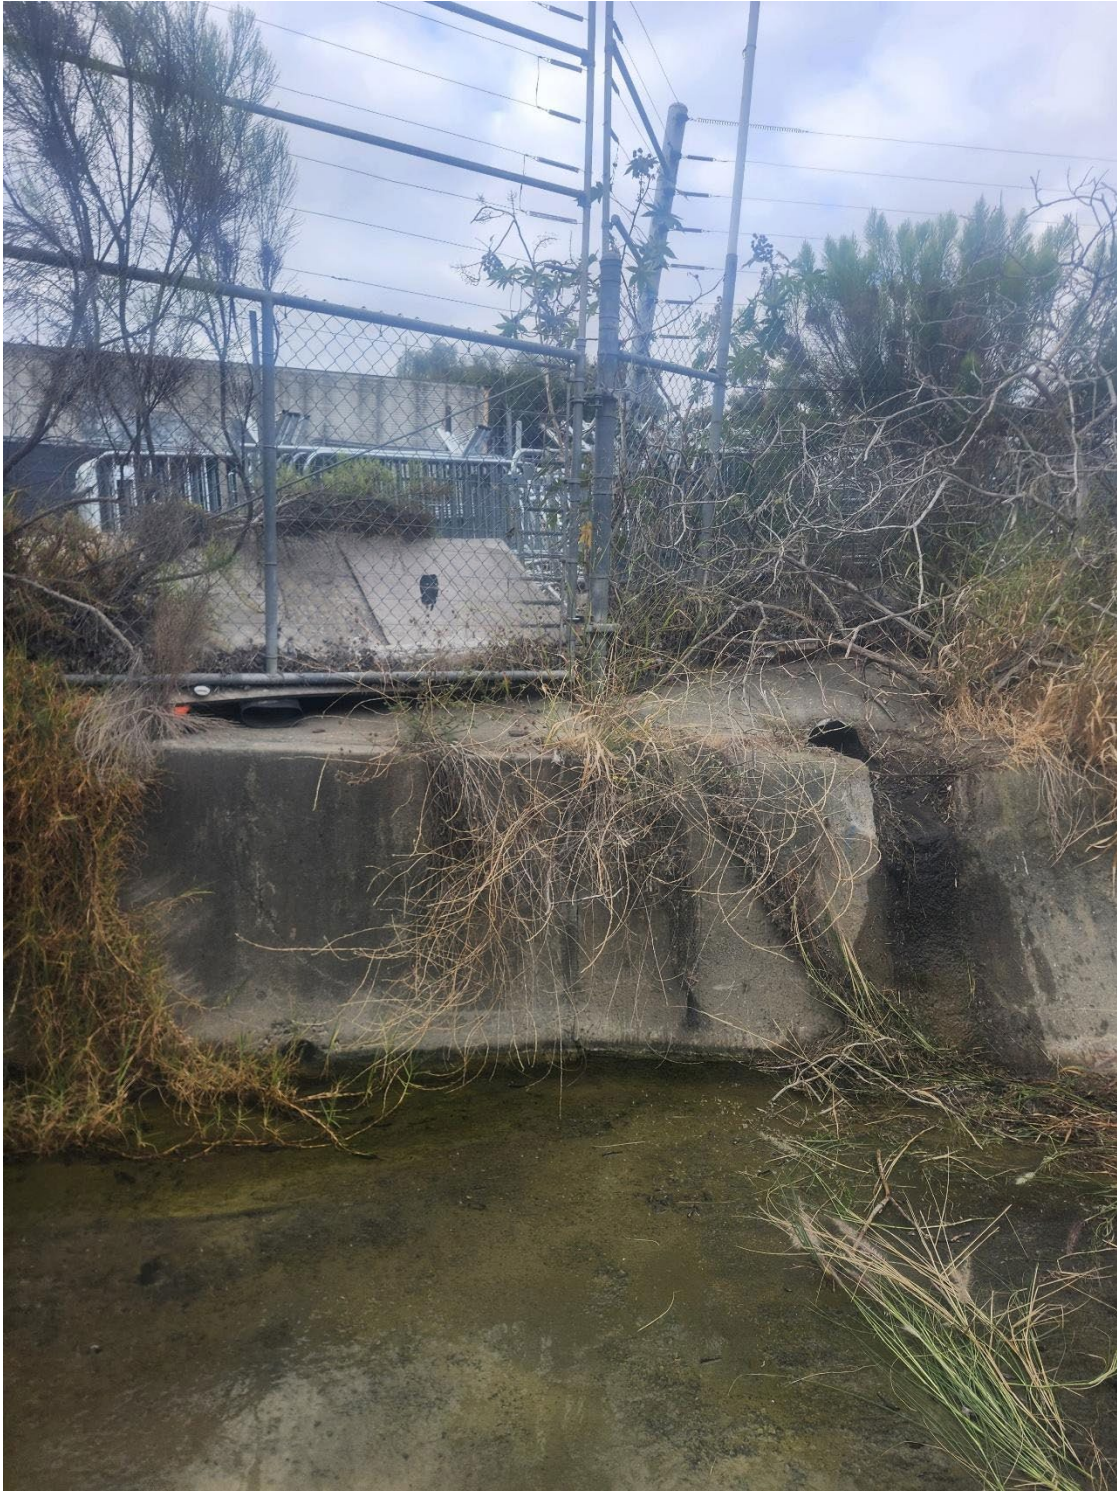
**B.4 — Concrete drainage structure in the channel (June 30, 7:24 am)**

A concrete drainage structure/apron in the channel with a dark void or opening (a possible culvert) emitting into the channel, with the electrified yard fence and utility lines above — a drainage feature warranting identification as it is concealed under the concrete berm.

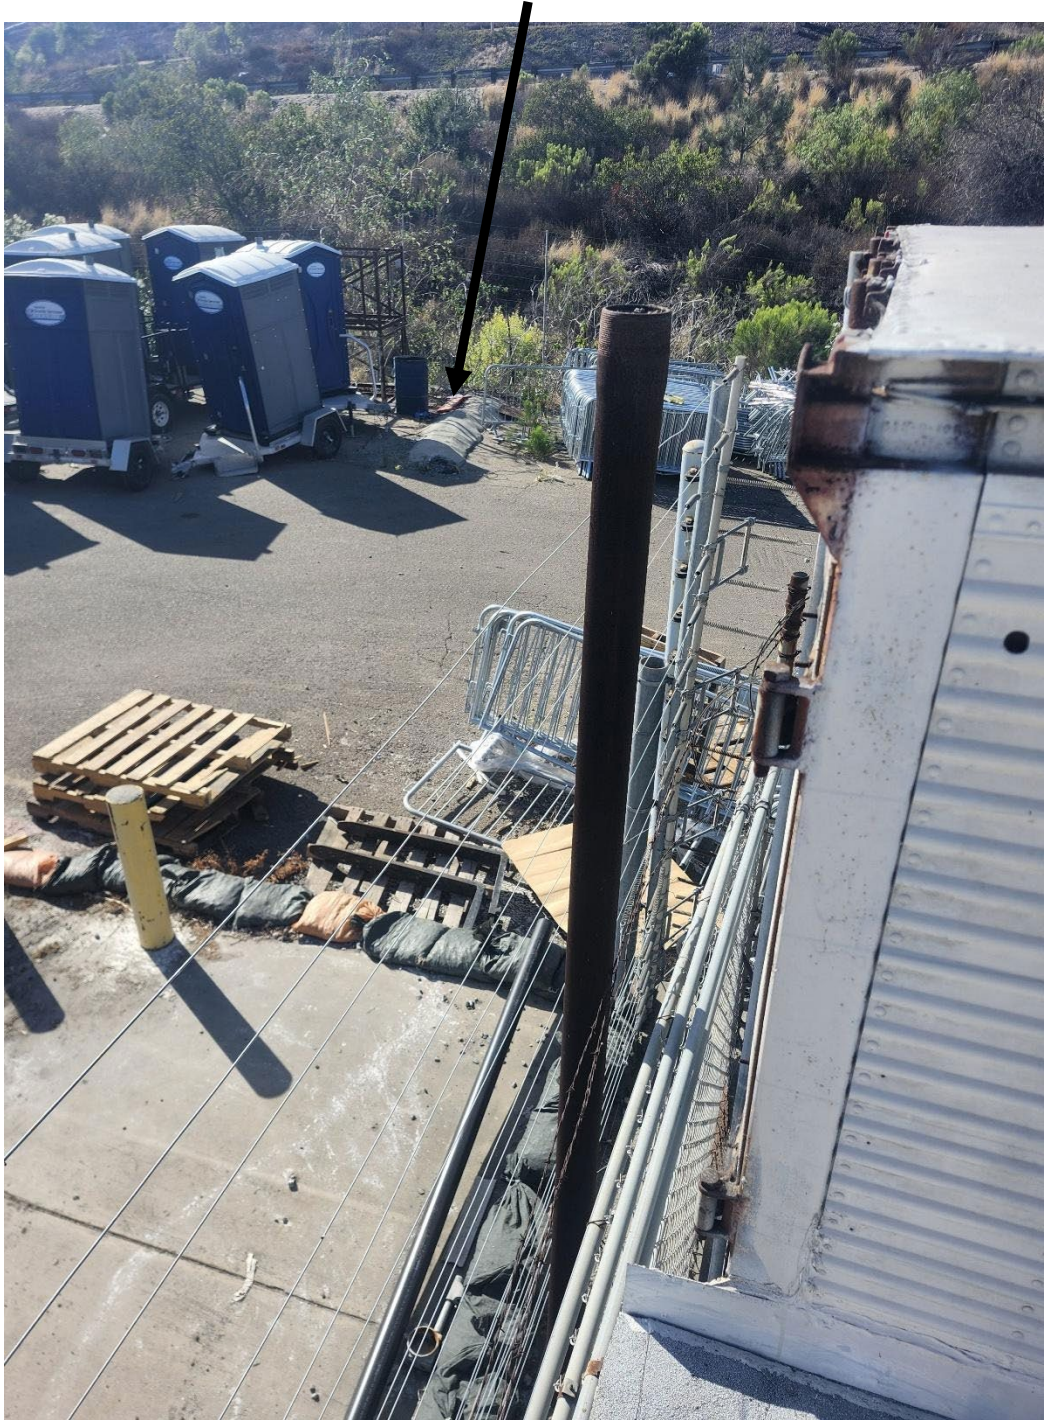
**B.5 — The yard and a clearly visible concrete berm (June 29, 4:56 pm)**

3. Records identifying the person(s) the inspector spoke with or corresponded with at United Rentals regarding the visit.
4. All records identifying the concrete berm/curb structure shown in photograph B.5 and any storm drain, pipe, or conveyance it conceals, contains, or connects to.

Elevated view down into the United Rentals yard: staged fencing, pipe, pallets, plastic-covered/sandbagged piles, and vehicles, with a clearly visible concrete berm along the yard edge nearest the channel. The berm sits directly in line with the site's approximately 21,000-gallon FRAC septage holding tank. The records request asks the City to identify this berm and any drain line it conceals or connects to.

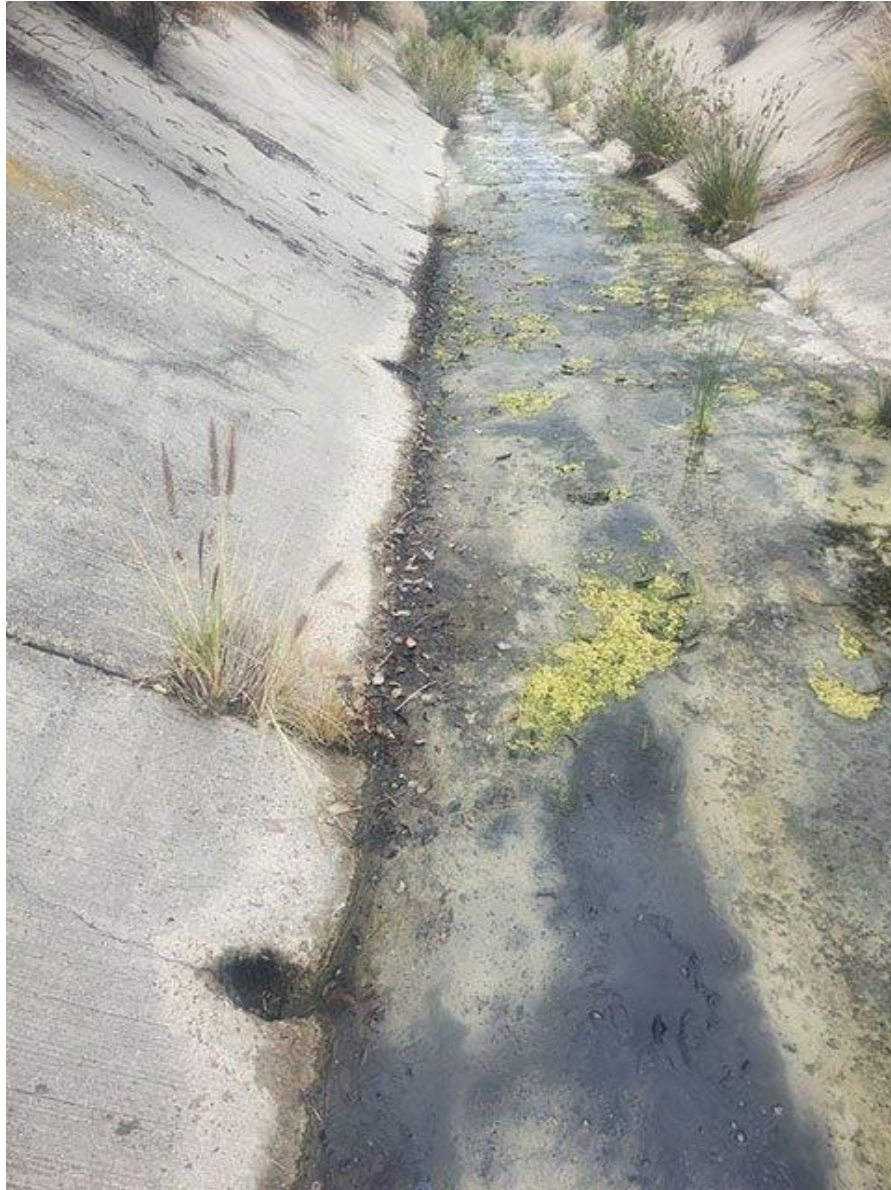
**B.6 — Nutrient-type algae and a wet stain at the slope base (June 30, 7:28 am)**

The channel invert with bright green/yellow algae and duckweed on slow, standing water, and a dark wet stain at the base of the slope — a possible seep or discharge point.

**Water-quality note — this section of the channel is already a designated impaired waterway with fecal-indicator bacteria detected above objectives.** A South Chollas Creek Channel water-quality assessment prepared by Rick Engineering (channel sampling dated March 9, 2017) identifies South Chollas Creek Channel as a tributary to Chollas Creek, which is “listed as an impaired water body” under Clean Water Act § 303(d) with “Indicator Bacteria” among the listed pollutants requiring a TMDL. That assessment’s own sampling of the channel measured total coliform at 5,000–8,000 and enterococcus at 240–700 organisms/100 mL — exceeding the Basin Plan objectives of 1,000 and 151, respectively. Because elevated fecal-indicator bacteria are already documented in this section of the channel, additional fecal loading from a new discharge could go undetected against the already-impaired background — which is precisely why identifying and sampling this outfall matters. Source: [Rick Engineering, South Chollas Creek Channel Initial Water-Quality Assessment \(2017\)](#).

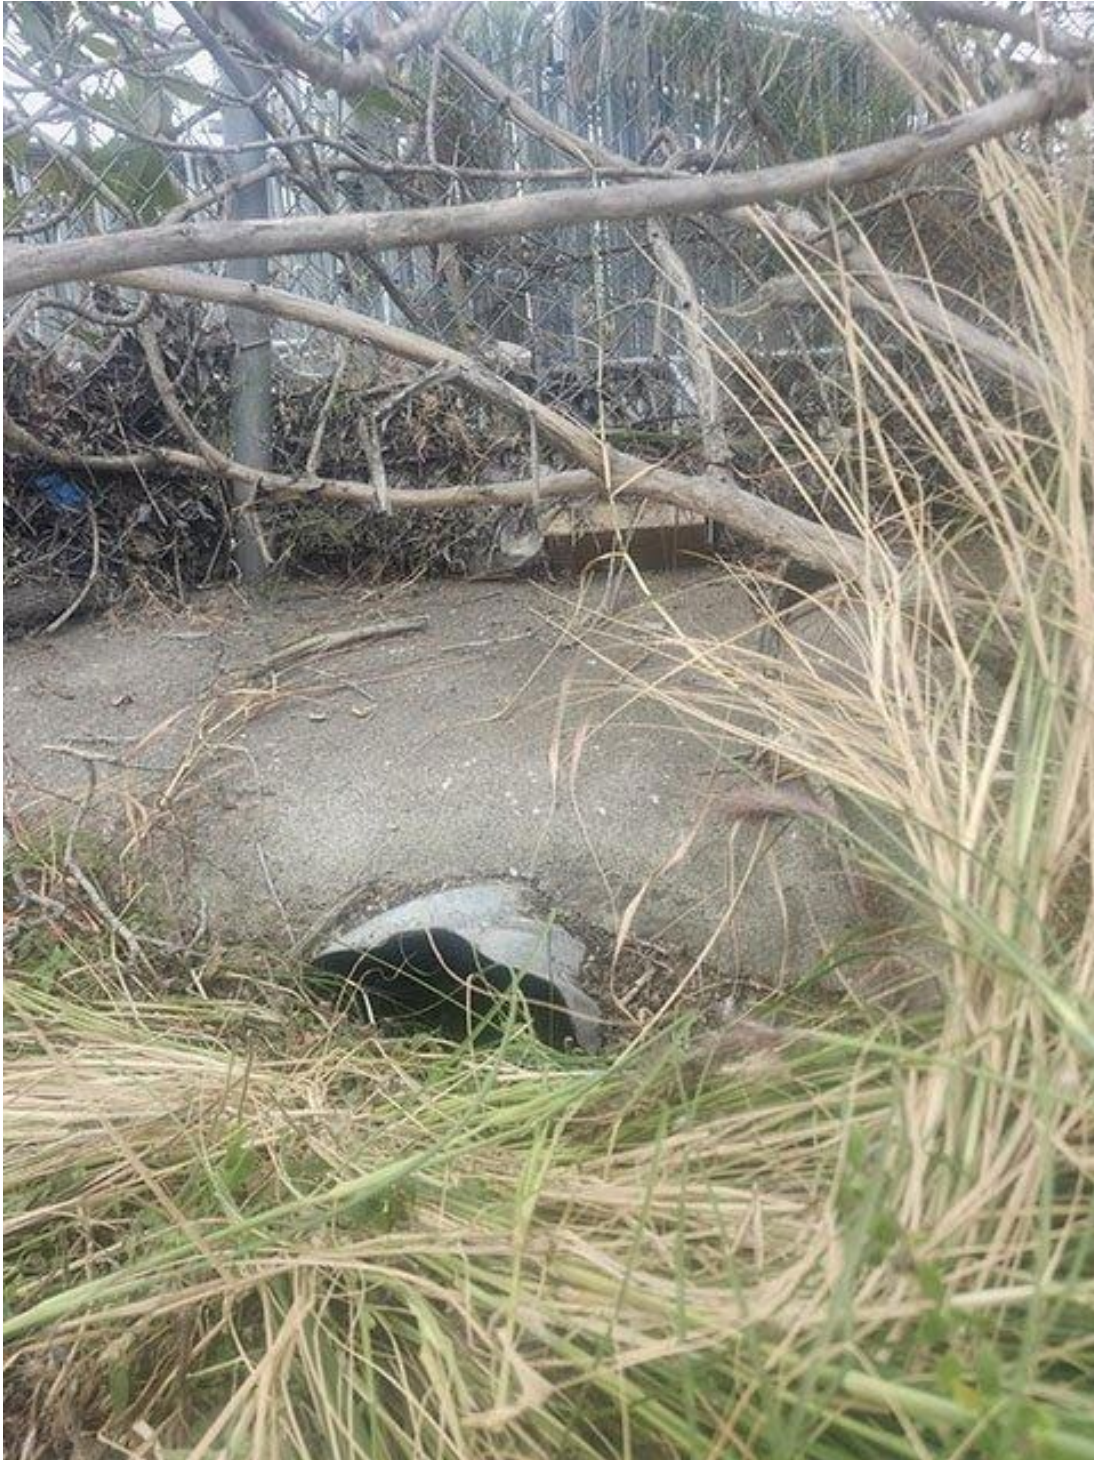
**B.7 — Pipe/culvert opening at the channel edge (June 30, 7:20 am)**

5. All records identifying the pipe/outfall (approximately ten inches) discharging at the channel sidewall shown in photographs B.7 and B.8 — including whether it is a permitted MS4 connection or an unpermitted / illicit connection, and any illicit-discharge detection and elimination (IDDE) investigation records for this location under MS4 Permit Order No. R9-2013-0001.

A pipe or culvert opening at the base of a concrete mass, tied to the berm on the opposite side of the fence at the top of the channel, partly concealed by grass — a structure associated with the outfall discharge into the channel below.

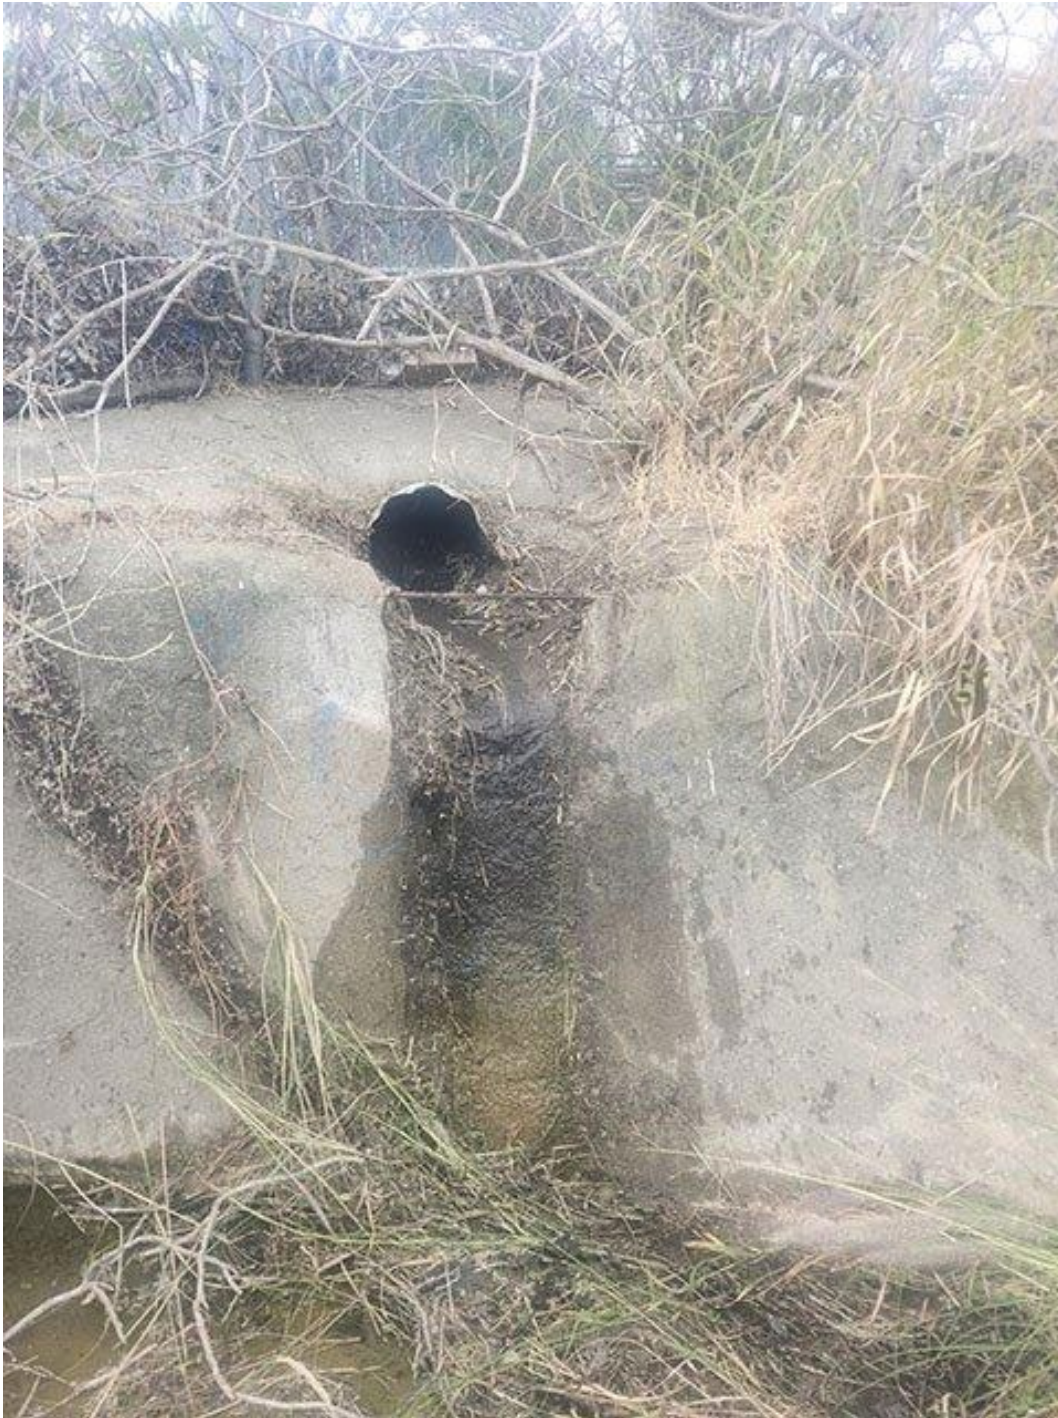
**B.8 — A pipe (~10 inches) with discharge (June 30, 7:23 am)**

A dark round pipe — roughly ten inches in diameter — protruding from the concrete channel sidewall.

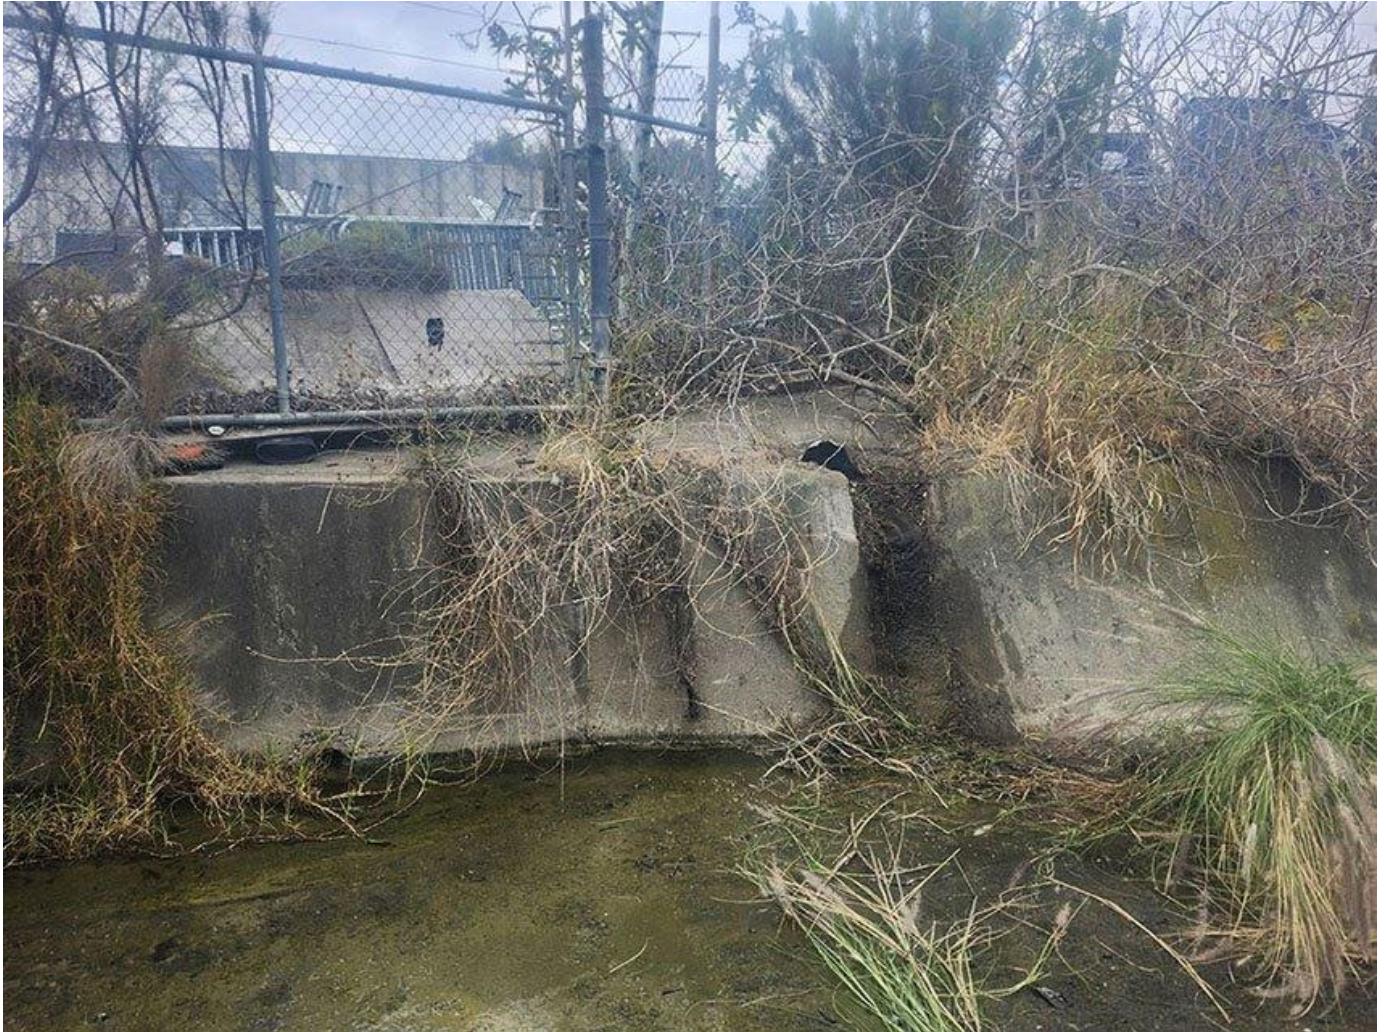
**B.9 — Yard, wall, and a discharge opening (June 30, 7:24 am)**

A low concrete wall/step with the United yard and building above and a dark opening at the top of the wall; algae and staining in the standing water below. Shows the spatial relationship between the yard, the wall, and a discharge point with liquid accumulation at the bottom of the channel.

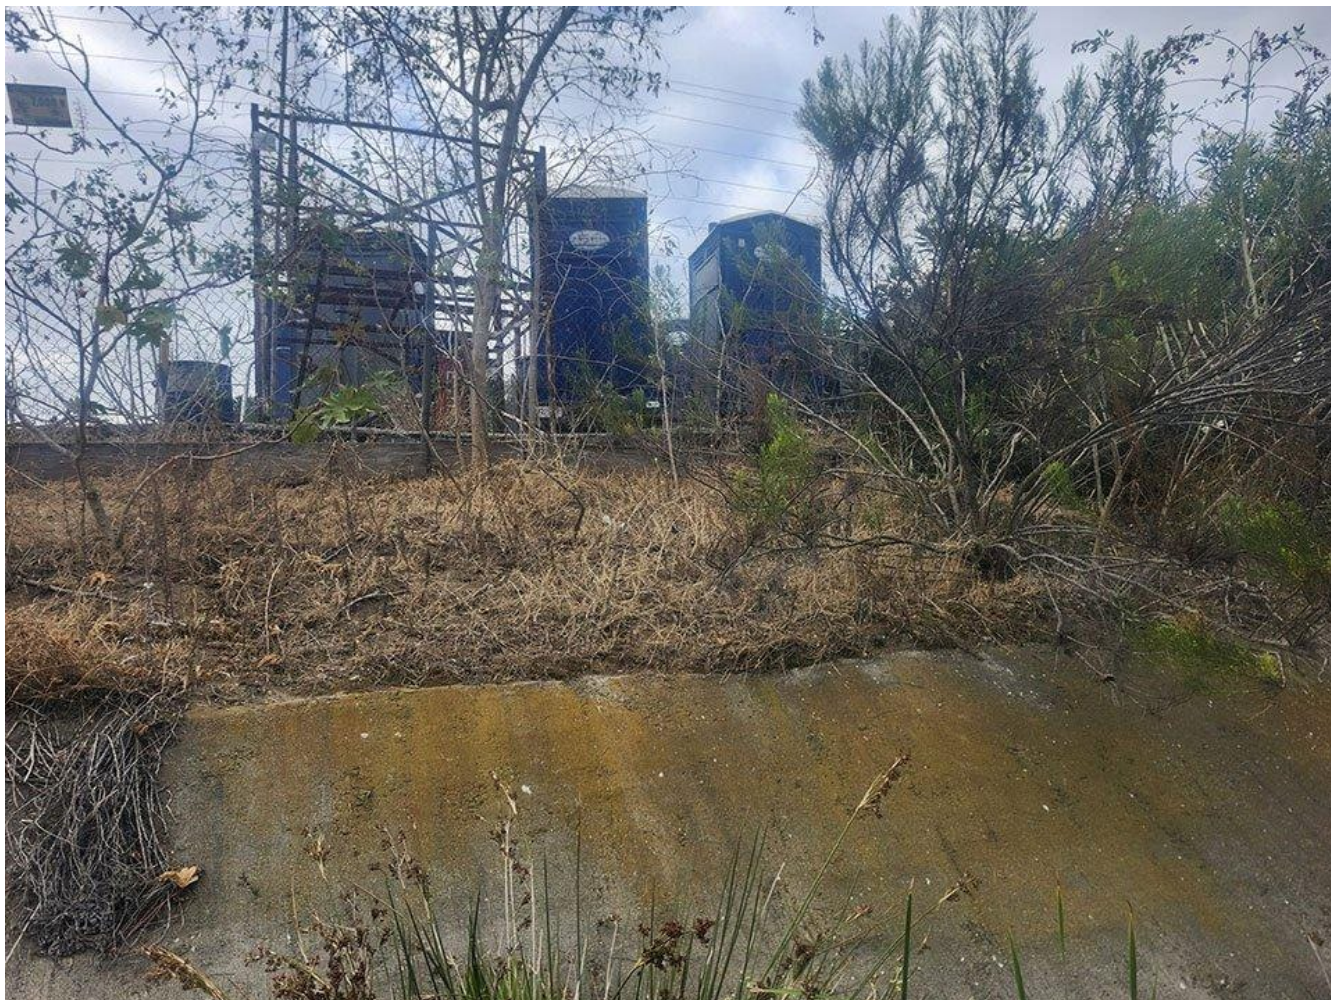
**B.10 — Broad staining down the slope below the yard (June 30, 7:25 am)**

The concrete channel slope directly below the yard — blue portable toilets are visible through the fence above — showing a broad brown/orange stain fanning down the concrete toward the water.
