# FRAC Tank Roof Vent — Corrosion & Explosion-Risk Analysis

Visual assessment of headspace/vent corrosion and ignitability on a tank in human-waste (septage) service

# 6144 Federal Blvd. San Diego, CA Timeline Images

Environmental Analysis Report — 6144 Federal Blvd., San Diego, CA

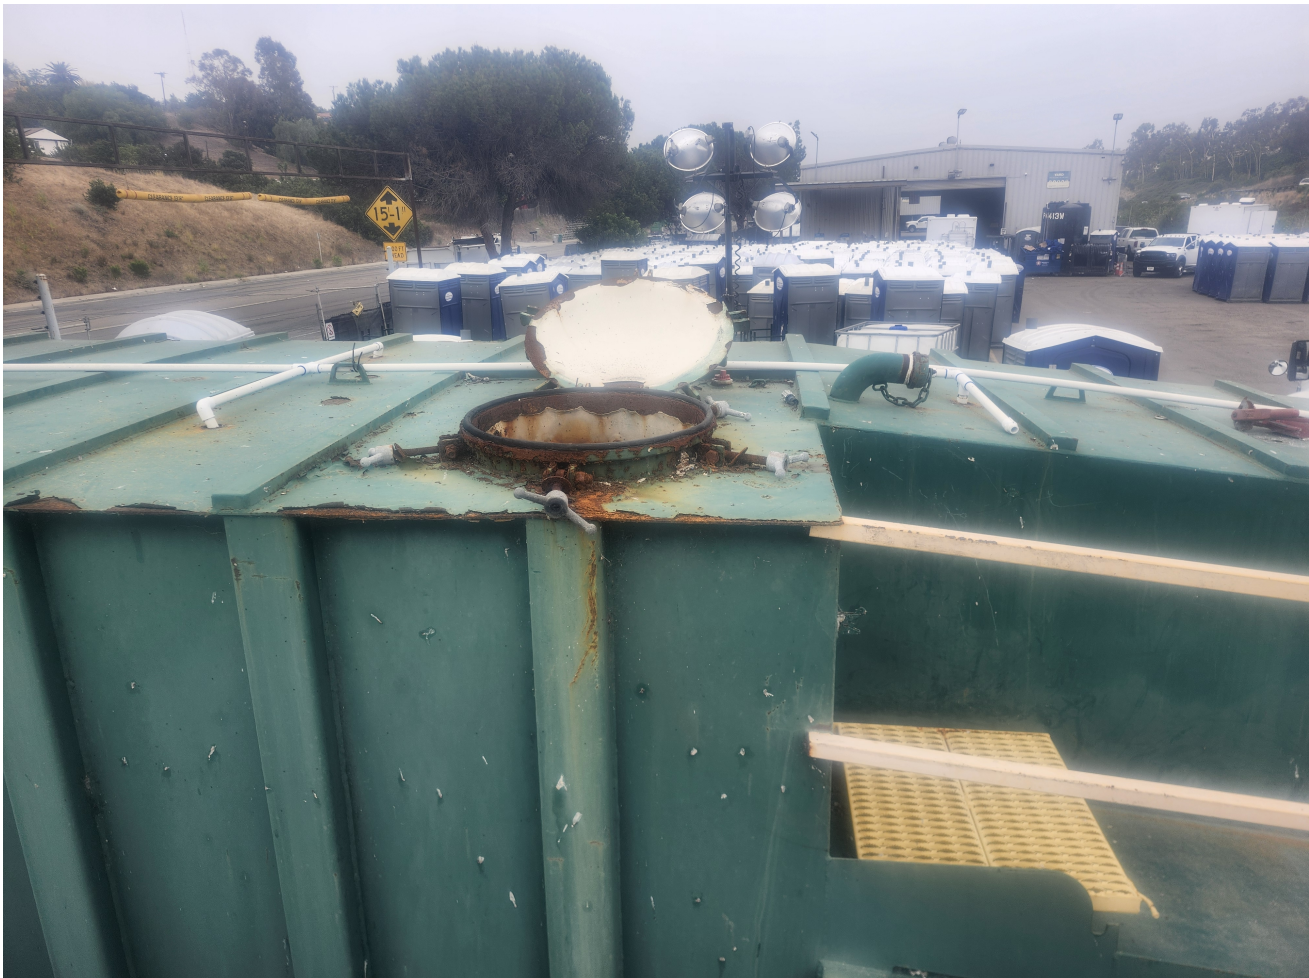
*Image 1 — Roof hatch in the open position. Note the heavily rusted manway collar and rim, corroded swing bolts, and rust staining streaking down the shell below the opening; the flat roof panels and shell retain largely intact green coating. (4000 × 3000 px)*

In both photos the corrosion is overwhelmingly concentrated at the manway/hatch: the rusted collar (coaming), the seam between the lid and the collar, and the associated swing bolts and hinge hardware. Image 2 shows laminar, flaking rust scale right at the lid-to-collar interface. Image 1 shows a continuous band of rust around the manway rim, with staining streaking *downward* onto the shell below it. Meanwhile, the large flat roof panels and the vertical shell still carry largely intact coating. That distribution — concentrated at the opening, washed-down staining, intact panels — is exactly what you would predict if the aggressive agent is a gas rather than something attacking the whole structure uniformly.

**Flame arrestor on the vent** — the single most important device, quenching a flame before it can travel back into the tank. Not visible. The openings look like a plain manway and simple ports, and with the hatch open the headspace vents straight to atmosphere with no arrestment.

**Plastic (PVC) vent piping** — the white roof piping appears to be plastic, a red flag on flammable service: it cannot be bonded or grounded, accumulates static, offers no flame-stopping capability, and fails at low temperatures. (Some white lines could be sight-gauge tubes rather than vents — not certain from photos.)

**Bonding and grounding** for transfer operations — not evident (no grounding lug, bonding cable, or reel visible). The cam-lock fill/discharge connection indicates loading/unloading, during which turbulent or splash filling generates static — a classic ignition mechanism without bonding and grounding.

To move from “consistent with” to “confirmed,” inspect the interior. Biogenic sulfuric acid attack leaves a characteristic etched, soft, sometimes gypsum-like product on the gas-exposed underside of the roof and hatch, worst near the top and tapering toward the liquid line. Testing the surface or scale pH (very low points to sulfuric acid) and checking for sulfates in the corrosion product would confirm the chemistry. Comparing corrosion above versus below the waterline on the interior is also diagnostic — gas-phase MIC attacks the headspace band hardest and largely spares the submerged steel.

Treat the tank now as a combined flammable, toxic, and confined-space hazard. Before any hot work on the corrosion, gas-free the tank, use continuous LEL and  $H_2S$  monitoring, and work under a hot-work permit with qualified procedures. Have a qualified engineer classify the area (NFPA 820 / NEC Article 500) and design or verify proper venting — a P/V conservation vent plus a flame arrestor sized per API 2000 — replacing corroded components and any plastic piping with bonded metallic systems. Add bonding and grounding for transfers, address or relocate the nearby lighting and electrical, and install hazard signage and gas detection. Confirm by inspection whether any flame arrestor or P/V valve exists and its condition.

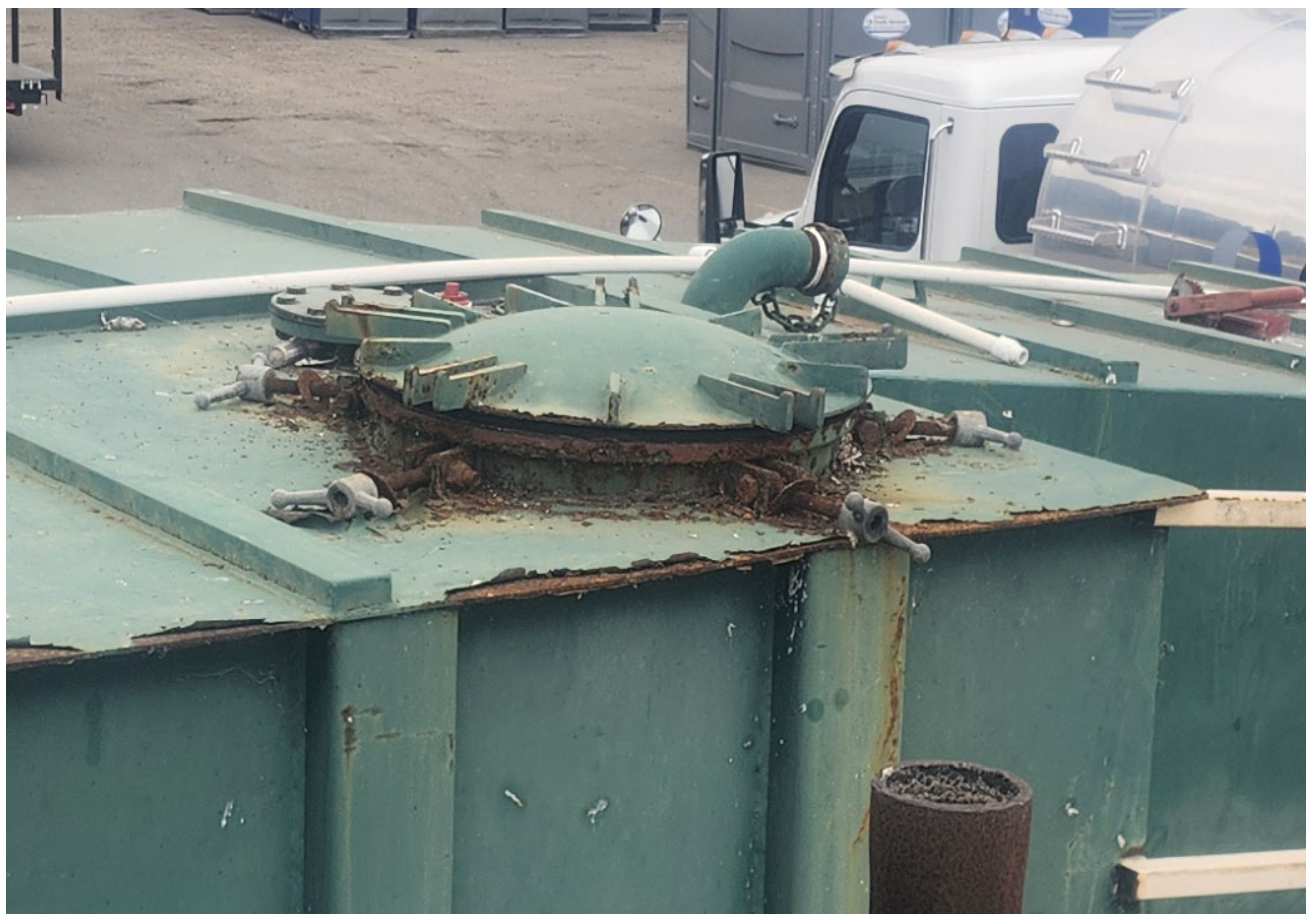
*Image 2 — Roof hatch in the closed position. Flaking, laminar rust scale is concentrated at the lid-to-collar seam and surrounding hardware, while the broader coated surfaces remain sound. (1044 × 726 px)*
