# 6144 Federal Blvd. San Diego, CA Timeline Images

The Before and After Environmental Effects of United Rentals Human Waste Batch Processing in a FRAC Tank as Unregulated Atmospheric Gas, Liquids and Solids Release.

Environmental Analysis Report — 6144 Federal Blvd., San Diego, CA

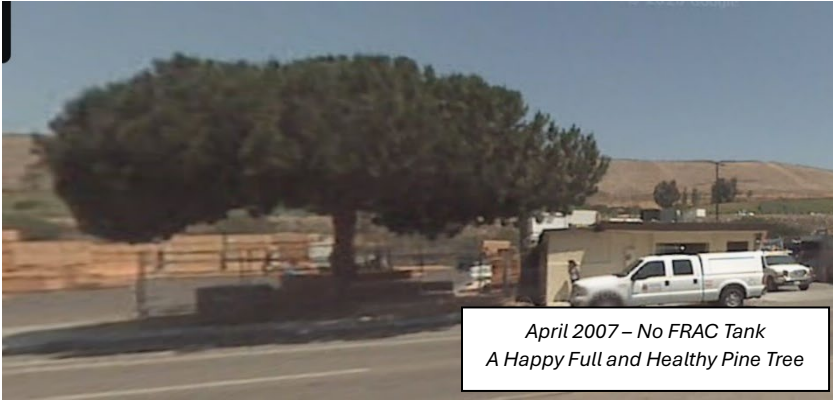
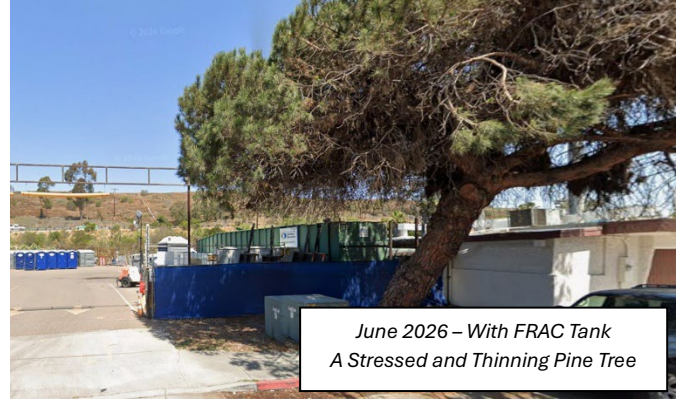
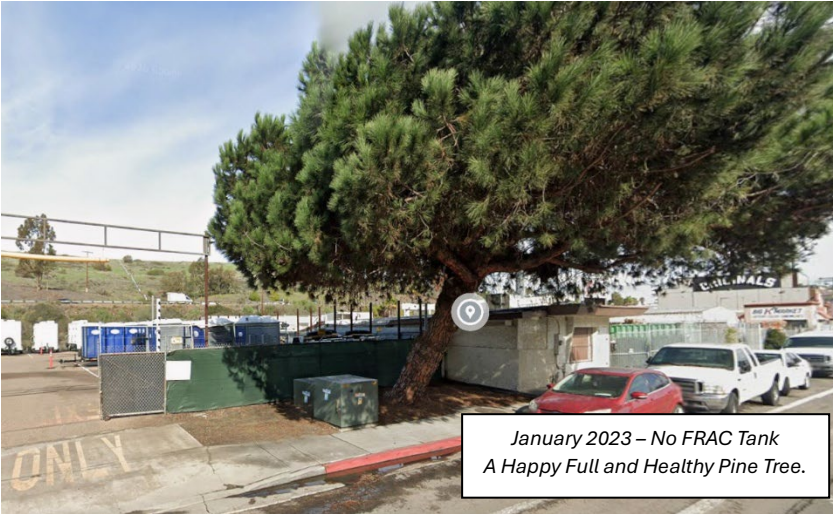
Historical Imagery < Jun 17, 2023 > | 2005 2006 2008 2009 2010 2012

The document presents a compelling chronological photographic and satellite record demonstrating a clear before/after inflection point around early 2024, coinciding with the FRAC tank being placed into service.

Date	FRAC Tank	Tree Condition
April 2007	Absent	Full, healthy, dense canopy
January 2023	Absent	Full, healthy, dense canopy
June 2023	Absent	Row of healthy, full pine trees
February 2024	<b>PRESENT</b>	First satellite evidence of tank in service
June 2026	<b>PRESENT</b>	Visibly stressed, thinning, sparse canopy

The document makes a critically important notation: *"None of the other trees West of this tree show this degree of distress."* This functions as a natural control group. If the decline were attributable to regional drought, disease, pest infestation, or soil-wide nutrient deficiency, neighboring trees of the same species would show similar symptoms. The fact that they do not strongly implicates a **localized, point-source stressor** — precisely what a FRAC tank in close proximity represents.
