**Constituent request — unpermitted human-waste storage at 6144 Federal Blvd. (District 4)**

# FRAC Tank Roof Vent — Corrosion & Explosion-Risk Analysis

Visual assessment of headspace/vent corrosion and ignitability on a tank in human-waste (septage) service

# FRAC Tank Off-Gassing & Pine Tree Decline

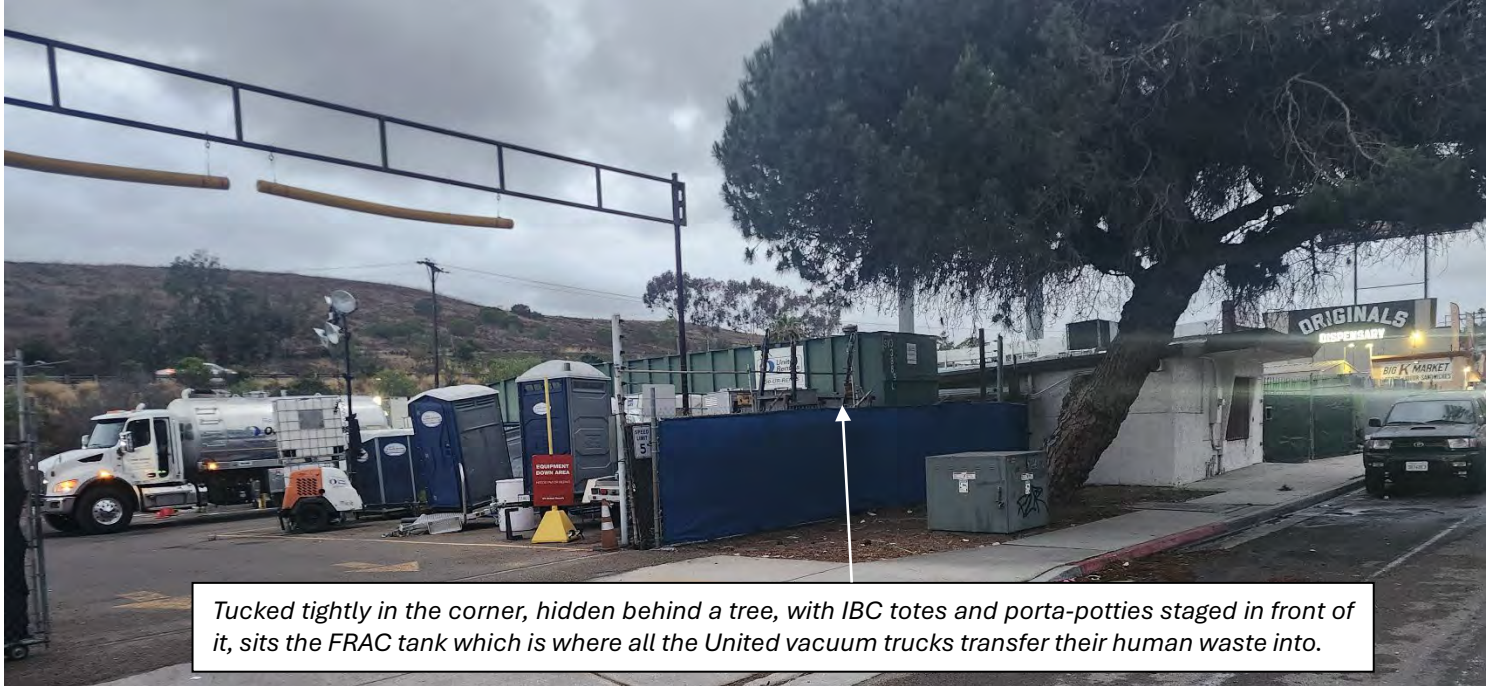
**Porta-Potty Rentals Main Human Waste Processing Center at 6144 Federal Blvd. SD CA 92114**

*Tucked tightly in the corner, hidden behind a tree, with IBC totes and porta-potties staged in front of it, sits the FRAC tank which is where all the United vacuum trucks transfer their human waste into.*

This is the United Rentals yard at 6144 Federal Blvd. looking Northeast. United Rentals did not place their human waste processing equipment at the West end of their property where they and their customers would have to smell the waste processing from their massive rental fleet of porta-potties. Instead, they located their main pump out station for their 10 or more of their waste hauling trucks, each carrying up to 4,000 gallons of rental porta-potty waste to the farthest Southeastern corner of their property in blatant disregard to their downwind neighbors. From morning until night these United vacuum trucks are continuously pumping that waste right next to Federal Blvd. and any easterly blowing wind moves that obnoxious odor into property all around Federal Blvd.

We, who have been affected by this process, would ask that United Rentals immediately come into compliance with these operations and remove and/or relocate their waste processing equipment to the opposite side of their yard and cease creating the unbearable stench that is an affront to those residential and business properties in our community.

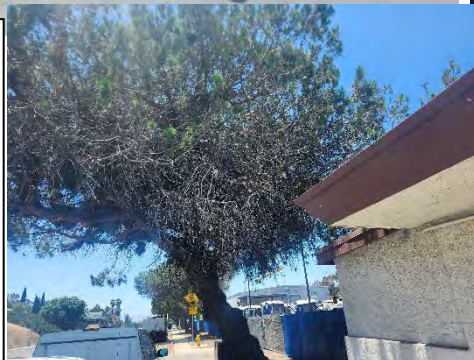
This mature pine tree shows classic stress from what may be the airborne toxic levels of Hydrogen Sulfide, Carbon Dioxide, Ammonia and Methane. All gasses generated by the anaerobic digestion of human waste. **These gasses also represent highly flammable and explosive risks under the current conditions.**

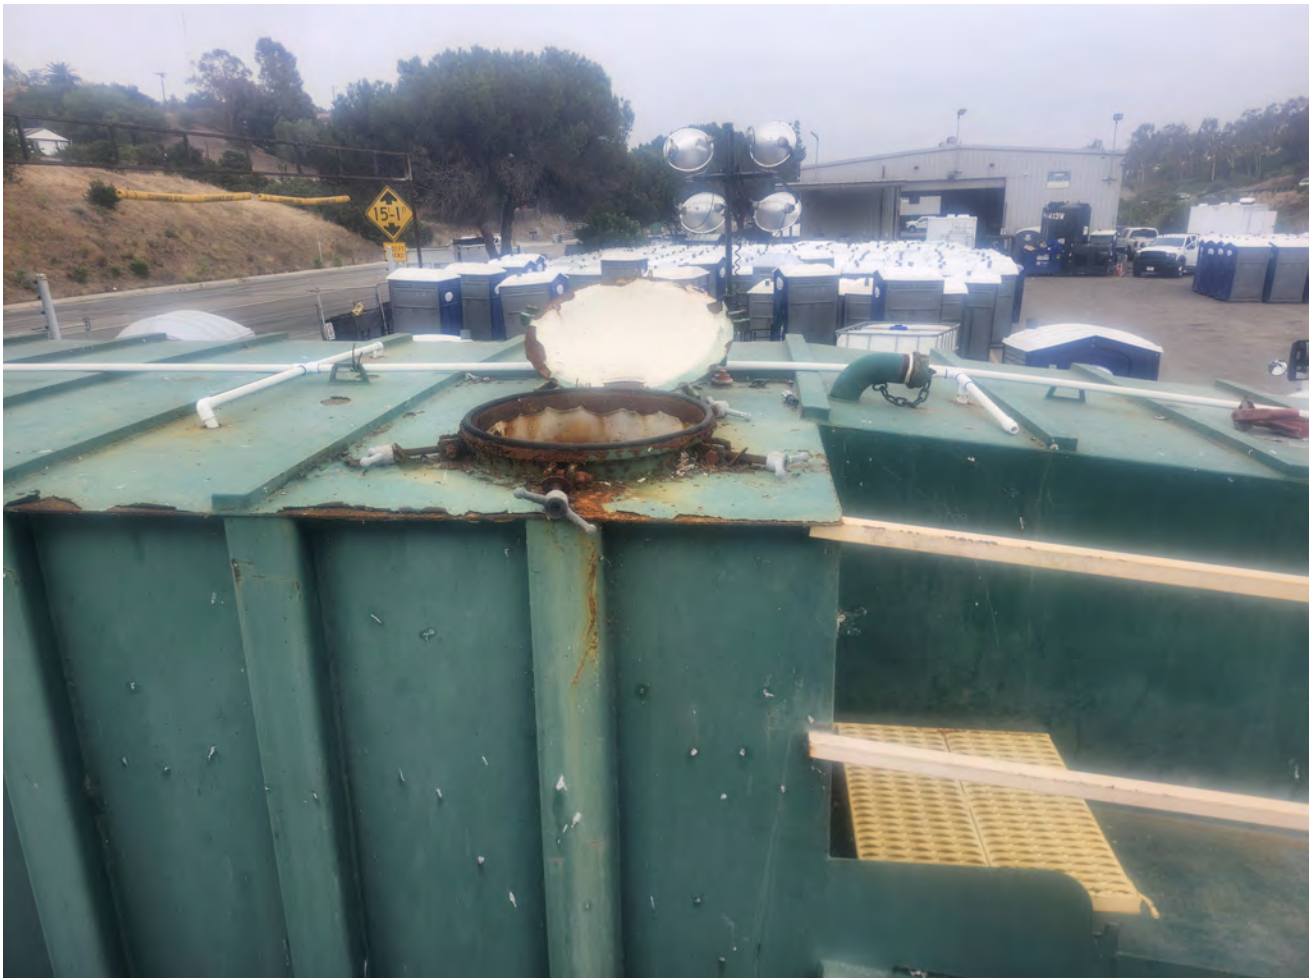
*Image 1 — Roof hatch in the open position. Note the heavily rusted manway collar and rim, corroded swing bolts, and rust staining streaking down the shell below the opening; the flat roof panels and shell retain largely intact green coating. (4000 × 3000 px)*

In both photos the corrosion is overwhelmingly concentrated at the manway/hatch: the rusted collar (coaming), the seam between the lid and the collar, and the associated swing bolts and hinge hardware. Image 2 shows laminar, flaking rust scale right at the lid-to-collar interface. Image 1 shows a continuous band of rust around the manway rim, with staining streaking *downward* onto the shell below it. Meanwhile, the large flat roof panels and the vertical shell still carry largely intact coating. That distribution — concentrated at the opening, washed-down staining, intact panels — is exactly what you would predict if the aggressive agent is a gas rather than something attacking the whole structure uniformly.

To move from “consistent with” to “confirmed,” inspect the interior. Biogenic sulfuric acid attack leaves a characteristic etched, soft, sometimes gypsum-like product on the gas-exposed underside of the roof and hatch, worst near the top and tapering toward the liquid line. Testing the surface or scale pH (very low points to sulfuric acid) and checking for sulfates in the corrosion product would confirm the chemistry. Comparing corrosion above versus below the waterline on the interior is also diagnostic — gas-phase MIC attacks the headspace band hardest and largely spares the submerged steel.

Treat the tank now as a combined flammable, toxic, and confined-space hazard. Before any hot work on the corrosion, gas-free the tank, use continuous LEL and H<sub>2</sub>S monitoring, and work under a hot-work permit with qualified procedures. Have a qualified engineer classify the area (NFPA 820 / NEC Article 500) and design or verify proper venting — a P/V conservation vent plus a flame arrestor sized per API 2000 — replacing corroded components and any plastic piping with bonded metallic systems. Add bonding and grounding for transfers, address or relocate the nearby lighting and electrical, and install hazard signage and gas detection. Confirm by inspection whether any flame arrestor or P/V valve exists and its condition.

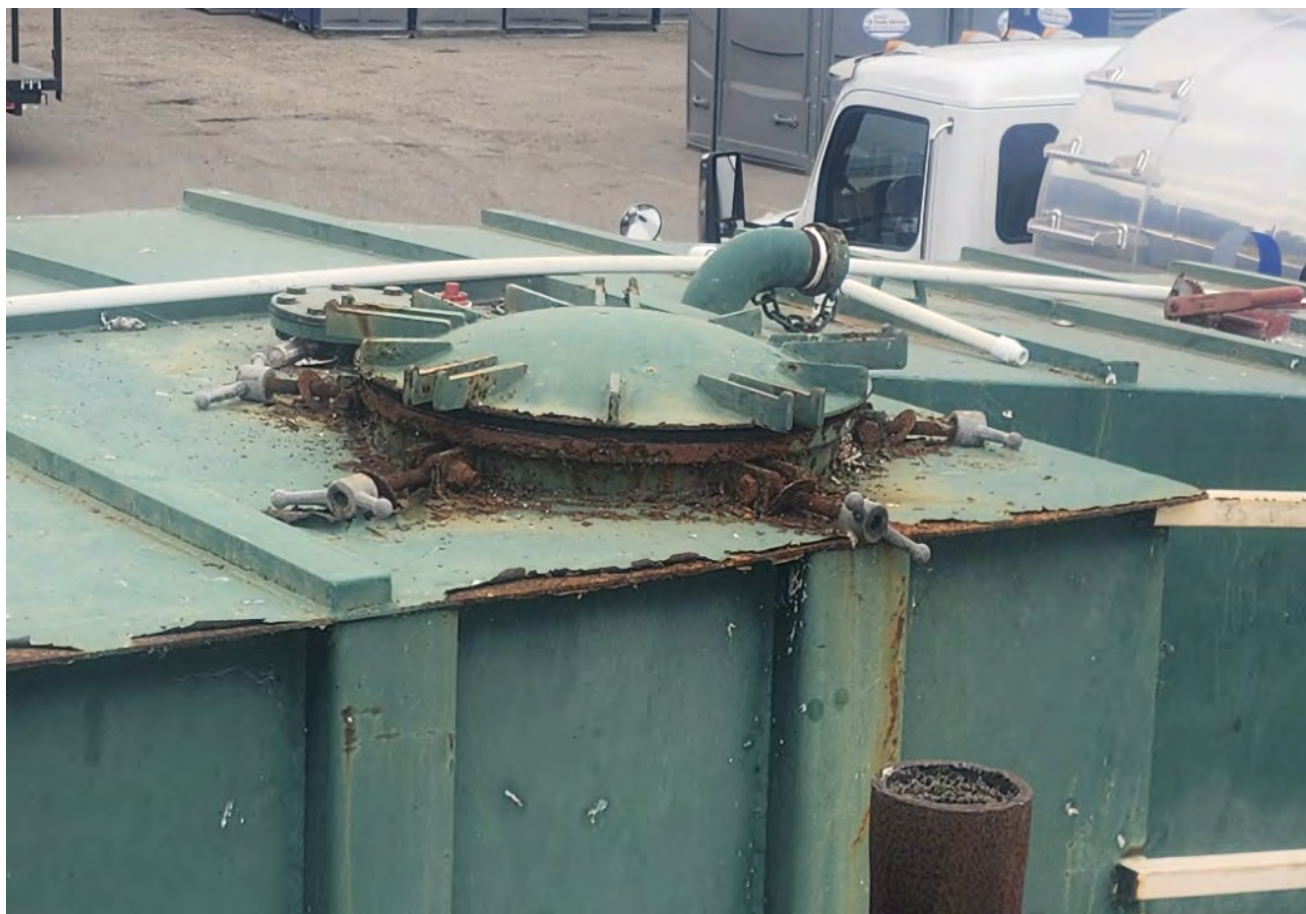
*Image 2 — Roof hatch in the closed position. Flaking, laminar rust scale is concentrated at the lid-to-collar seam and surrounding hardware, while the broader coated surfaces remain sound. (1044 × 726 px)*

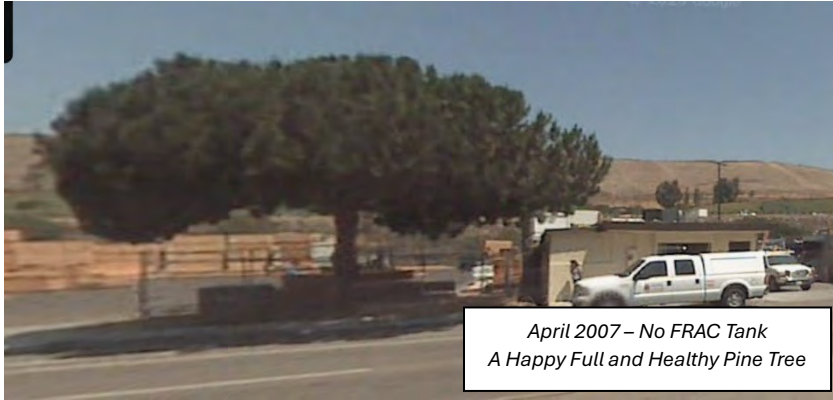
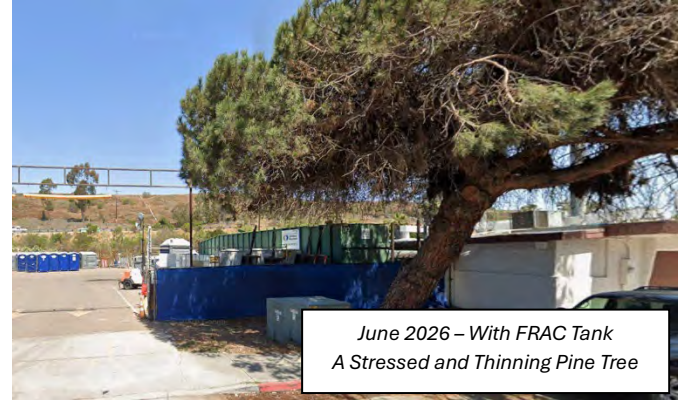
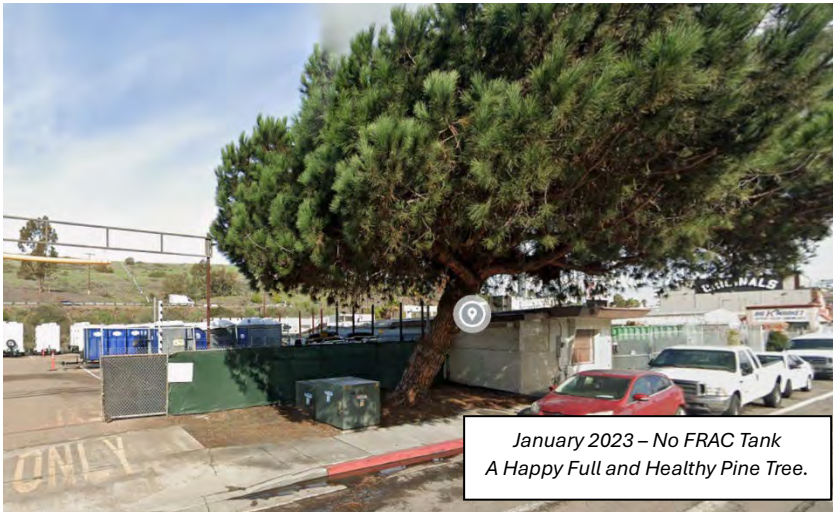
Historical Imagery < Jun 17, 2023 > | 2005 2006 2008 2009 2010 2012

The Before and After Environmental Effects of United Rentals Human Waste Batch Processing in a FRAC Tank as Unlawful Atmospheric Gas, Liquids and Solids Release.

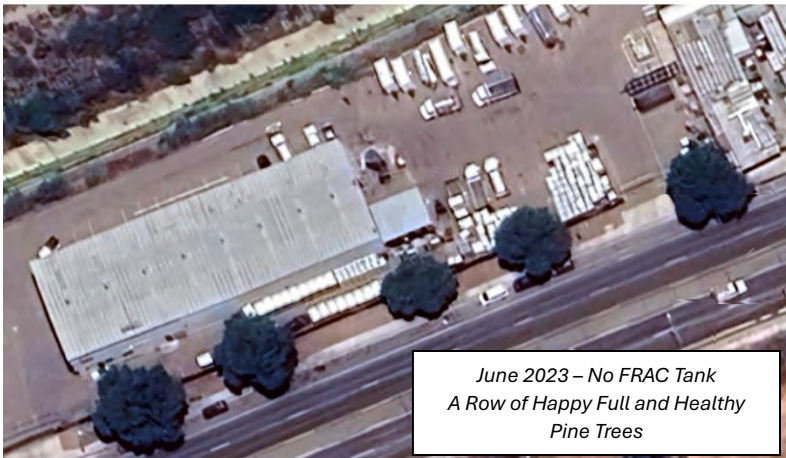
Dated satellite imagery brackets when the tank appeared. The June 17, 2023 frame shows the southeast corner with no FRAC tank; the next available frame, February 11, 2024, shows a tank consistent with the green FRAC tank in that same corner, alongside the staged porta-potties and totes. The tank has therefore been in place since at least February 2024 — more than two years, roughly 29 months — with the adjacent owner's first-hand account placing the activity there at least that long. For an installation this size, visible from space and feet from homes and businesses, no agency appears to have inspected the tank itself in that entire span.
