# FRAC Tank Roof Vent — Corrosion & Explosion-Risk Analysis

Visual assessment of headspace/vent corrosion and ignitability on a tank in human-waste (septage) service

# 6144 Federal Blvd. San Diego, CA Timeline Images

Environmental Analysis Report — 6144 Federal Blvd., San Diego, CA

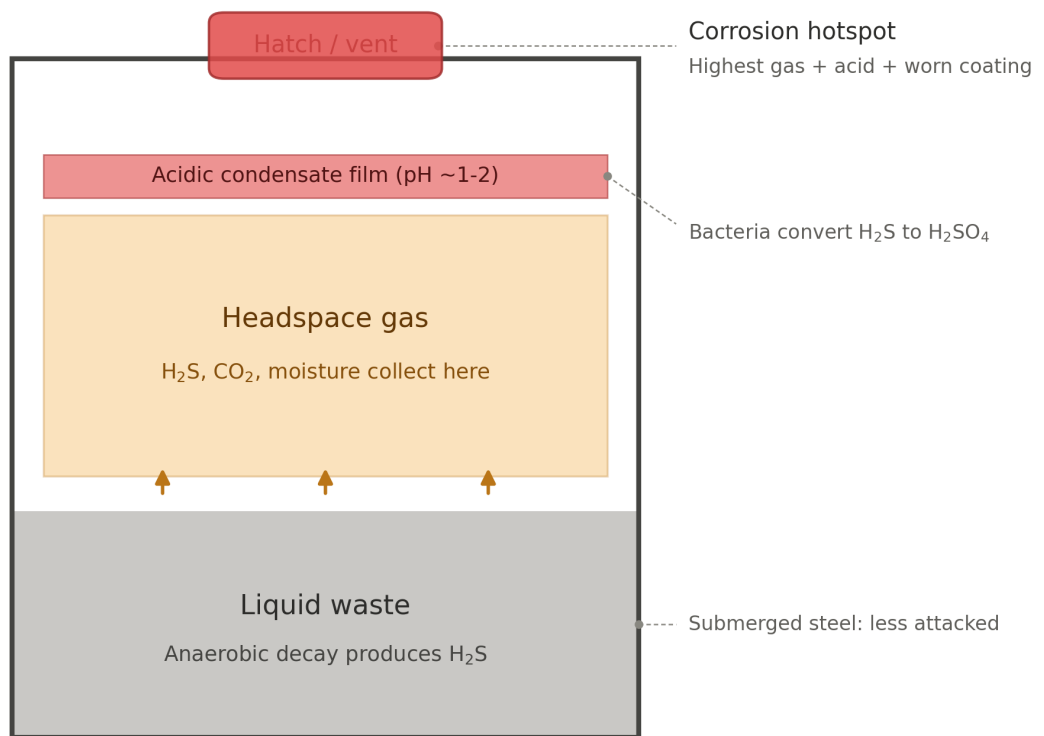
This is the same process that destroys the crowns of concrete sewer mains and the headspace of lift stations and wet wells — classic microbiologically influenced corrosion (MIC). The key point for the hypothesis: the attack lives in the gas phase above the waterline, not on the submerged steel, and it is worst at the very top where the gas concentrates, condensate forms, and the acid drips. Opening the hatch to fill or service vents concentrated gas right at that interface and cycles in fresh humid air.

*The aggressive zone is the vapor space, not the wetted steel*

*Cross-section of the corrosion zones. The aggressive attack occurs in the vapor space at the top — at and around the hatch/vent — not on the submerged steel.*

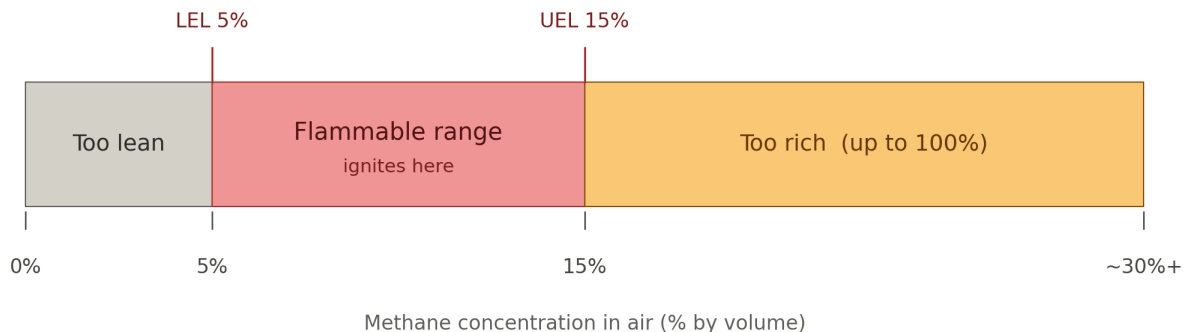
A fully sealed, gas-rich headspace may actually be too rich to ignite (and oxygen-starved). The hazard is that every time the hatch is opened, the tank is vented, or product is transferred, the mixture sweeps down through the flammable window as it meets air — at exactly the spots showing the most corrosion. Absent properly installed and maintained ignition-control features, the evidence of these gases constitutes a legitimate ignitable/explosive risk: a flammable atmosphere, plus an ignition source, plus oxygen.

Sealed headspace often sits above 15%: too rich to ignite, but oxygen-starved

Where gas meets air (open hatch, vent outlet) it passes through the 5-15% window

Treat the tank now as a combined flammable, toxic, and confined-space hazard. Before any hot work on the corrosion, gas-free the tank, use continuous LEL and  $H_2S$  monitoring, and work under a hot-work permit with qualified procedures. Have a qualified engineer classify the area (NFPA 820 / NEC Article 500) and design or verify proper venting — a P/V conservation vent plus a flame arrestor sized per API 2000 — replacing corroded components and any plastic piping with bonded metallic systems. Add bonding and grounding for transfers, address or relocate the nearby lighting and electrical, and install hazard signage and gas detection. Confirm by inspection whether any flame arrestor or P/V valve exists and its condition.

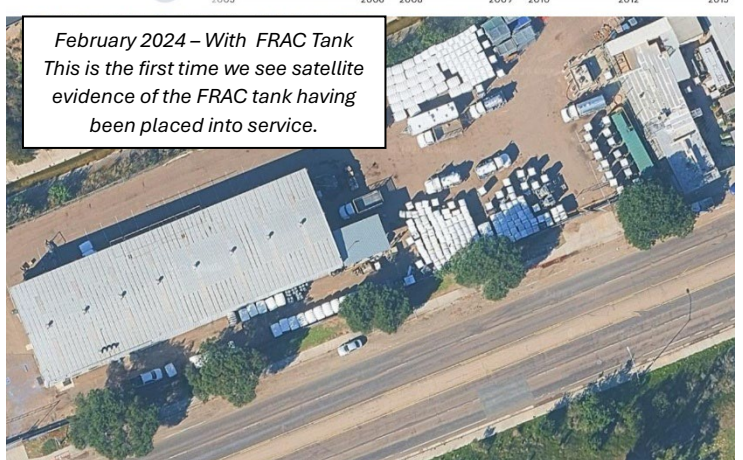
*February 2024 – With FRAC Tank  
This is the first time we see satellite evidence of the FRAC tank having been placed into service.*
